Section 5 referral Reference R25-54 - Drumcliffe Union of Parishes

Are the conservation led repairs to windows, masonry, plaster, leadwork and chimneys all at Kilfenora Cathedral, which is a protected structure RPS 124, development and if so, are they exempted development?

This Method Statement is prepared to inform proposed conservation and repair works. Appropriate programming for repair works has thus far consisted of:

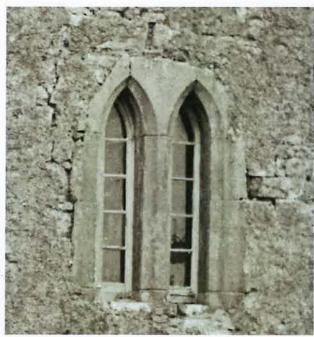
WF-05, West Gable, Lawrence Collection, c.early 20th century, Robert French, © National Library of Ireland

West Elevation - WF-05, Two light, each 5 pane, gothic arched window with cut stone dressing and fixed sashes. Note presence of wire grills in later image.

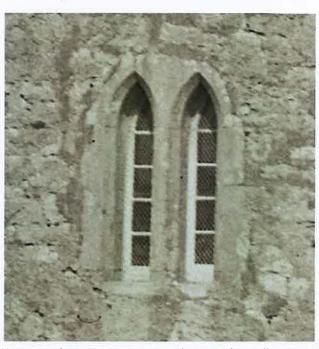
WF-05, Irish Tourist Association Photographic Collection, 1942, © National Library of Ireland

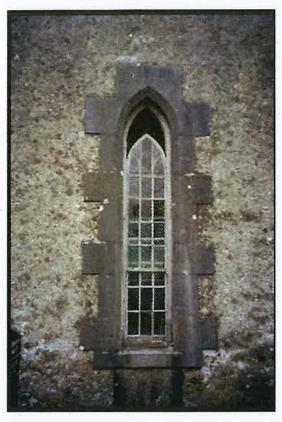
Southern Elevation - Window openings WG-02 and WG-03 on the southern elevation were enlarged in the 1830s, and two additional window openings WG-08 and WG-10 were created, with the former window unit WG-03 possibly refitted at high level on the northern elevation. 4 No. matching tall narrow windows with gothic lancet style heads fitted. The entrance door DG-04 was also altered. These openings now house 18 over 12 tall narrow sash windows with pointed (drop) arch heads.

One of the southern sash windows in 1997, Note presence of a wire grill outside the window. Source NBHS

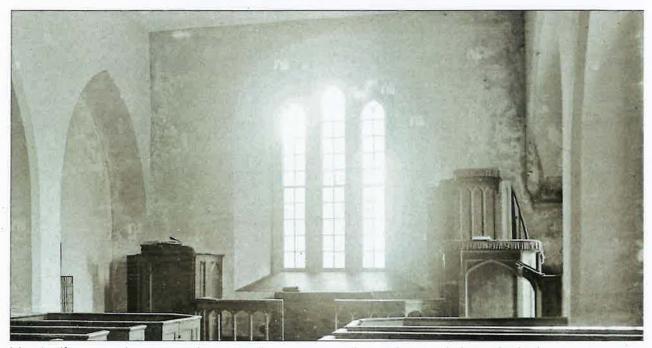
'Church Kilfenoro Co. Clare 4139 W.L.' WG-06, William Lawrence Collection © National Library of Ireland

East Elevation - WG-06, Within the chancel, 'is a fine window made up of three narrow lancet lights. This window was inserted around 1835 and replaced an opening DG-01 into the former chancel, now ruined.' (p.15 CMP).

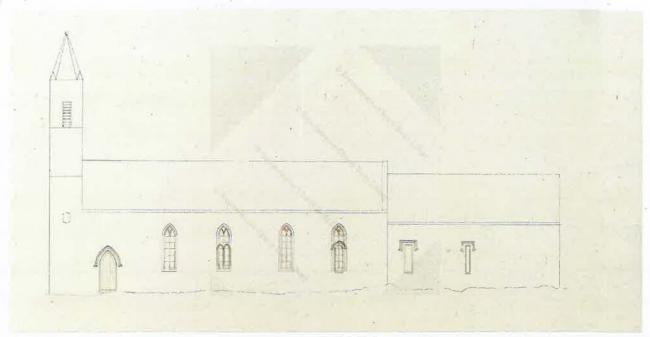
Proposed drawing of improved southern elevation, James Pain, c.1835. Note overlay of former windows. © RCB Library

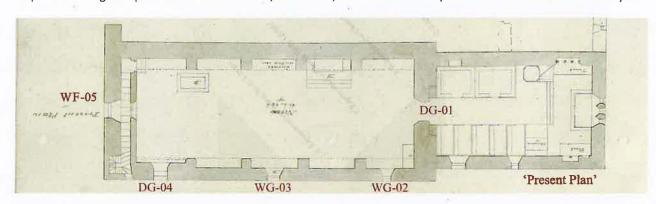
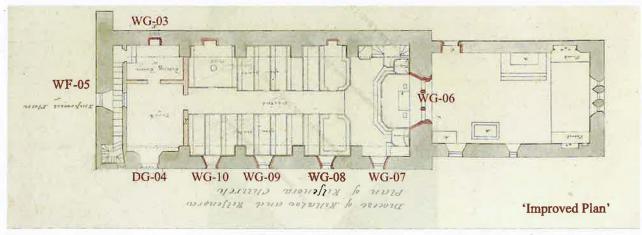
'Present and Improved Plan' James Pain, 1835, © RCB library. Note Plans rotated and window references added in Red, North is up. The 'present plan' represents the church prior to the 1830s alterations.

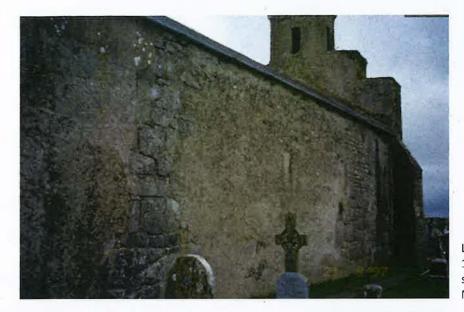
Looking at the North Wall, August 1997. Note the lack of chimney stacks above the roofline. Source: NBHS

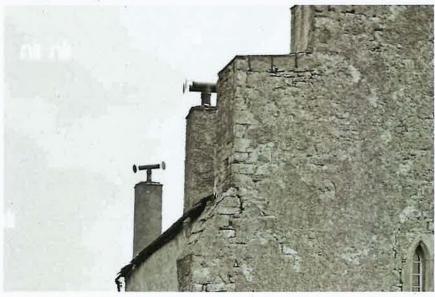
Detail of the North side showing chimney stacks, circa early 20th century, Note the unusual wind/rain cowling solution. Source: Lawrence Collection NLI.

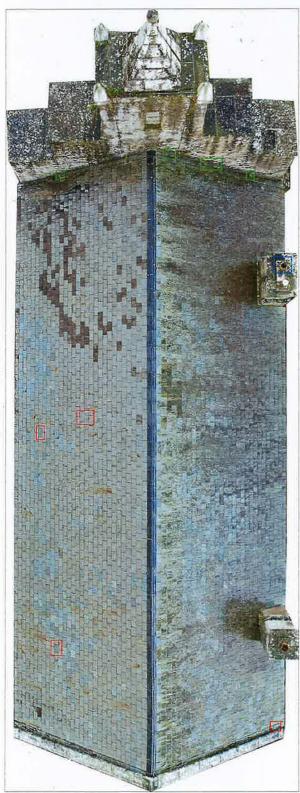
Plate 19. Photo of roof of the cathedral. Red=broken or missing slates; Blue=missing cowl on chimney pot; Green=vegetation along flashing suggestive of water issues. North to right.

- Tops of flues are to have rainguards, the type and the specification of which is to be agreed with the conservation architect. Selected rainguard to be compatible with future fitting of freestanding stoves the fitting of which shall be subject to necessary agreements and statutory approvals.

- Replace inadequate lead flashings to surrounds of chimney stacks, all in Code 5 lead.
- Replace missing slates on the roof slopes.
